ADDENDUM NO. 2

REQUEST FOR PROPOSAL IRVINE SPORTSPLEX ARENA UPGRADES - HAMLET OF IRVINE CONSULTING ENGINEERING SERVICES

IRVINE SPORTS COMPLEX, IRVINE, AB HAZARDOUS MATERIALS BUILDING ASSESSMENT

Project# SQ1MH25201
August 12, 2025

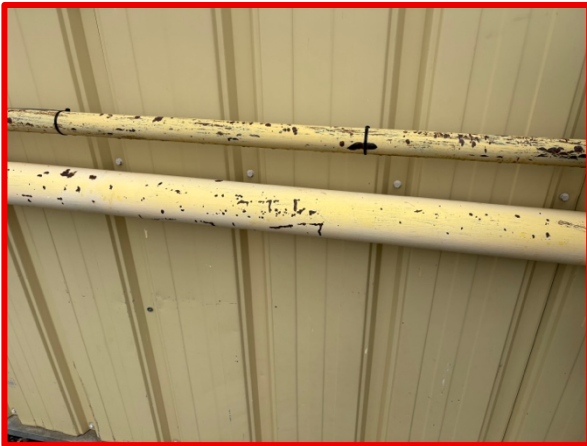
L1	West Exterior Pipe	Yellow Paint
----	--------------------	--------------

Below is a list of all paint samples that returned greater than 0.009%. If any of the materials below will be altered either during renovations or demolition, all precautions should be taken to limit the amount of lead release and to ensure air levels never exceed the Occupational Exposure Limit.

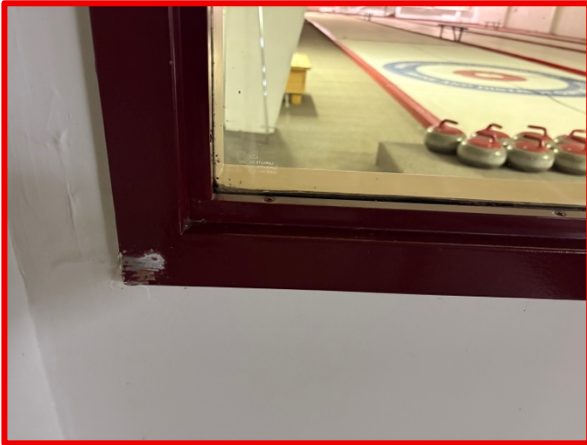
L9	Curling Rink Window Trim	Red Paint
----	-----------------------------	-----------

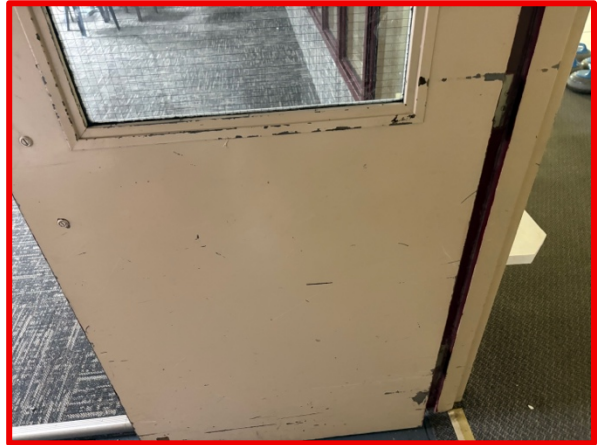
L10	Curling Rink Entrance Door	Drk. Tan Paint
-----	-------------------------------	----------------

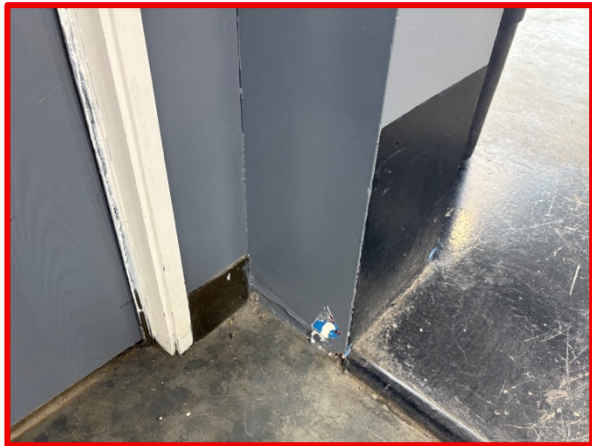
L11	Eating Area Wall	Blue Paint
-----	------------------	------------

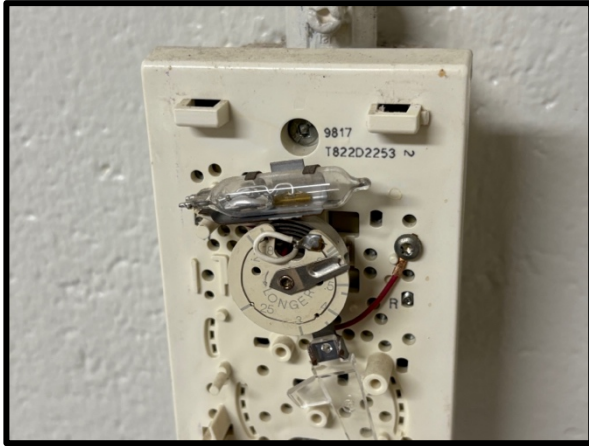
- Ten (10) thermostats containing a mercury bulb was found in the mechanic's shop beside the doorway to the street sweeper garage.

Mercury	Thermostat
---------	------------

If fluorescent lighting tubes and thermostats identified during the assessment are to be disposed, procedures in accordance to the Waste Control Regulations under the Alberta Environmental Protection and Enhancement Act must be used.

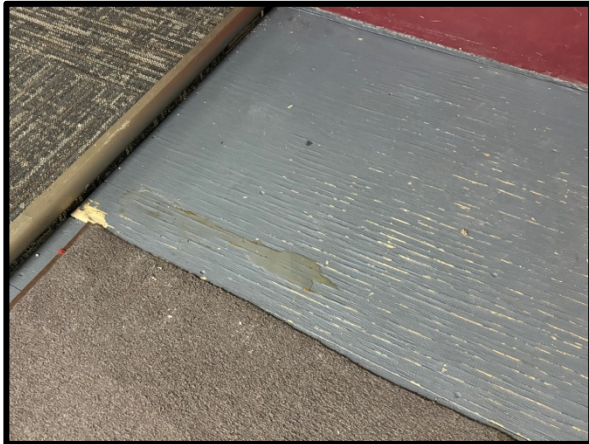
- Entrance to Curling rink – water leaking from A/C unit
- North Entrance beside kitchen – Door leaks and pipes leaking in ceiling
- Ammonia Plant – Water damage on walls and ceiling

Water Damage	Entrance to Curling Rink
--------------	--------------------------

All areas where water damage was observed should be fixed. At this moment there is no concern for mould growth.

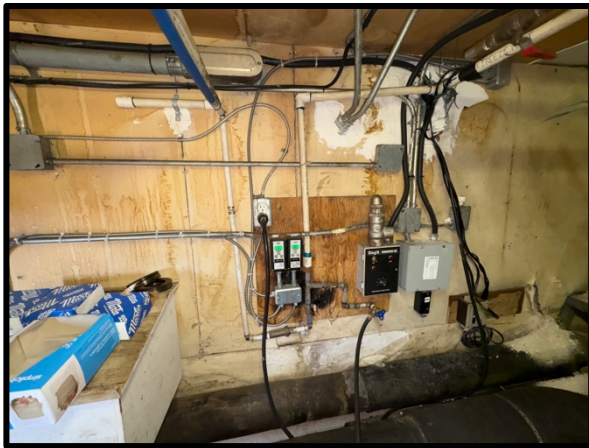
Water Damage	Ammonia Plant
--------------	---------------
