Riparian Health Inventory Report Seven Persons Creek Project Area

Interim Report: Year One

Project Area:
Seven Persons Creek
Murray Lake downstream to the City of Medicine Hat boundary including
Nine Mile Coulee and 'Knodel' Reservoir

Prepared by:
Cows and Fish
Alberta Riparian Habitat Management Program
2nd Floor, YPM Building
530 – 8th Street South
Lethbridge, Alberta, Canada
T1J 2J8
(403) 382-4345

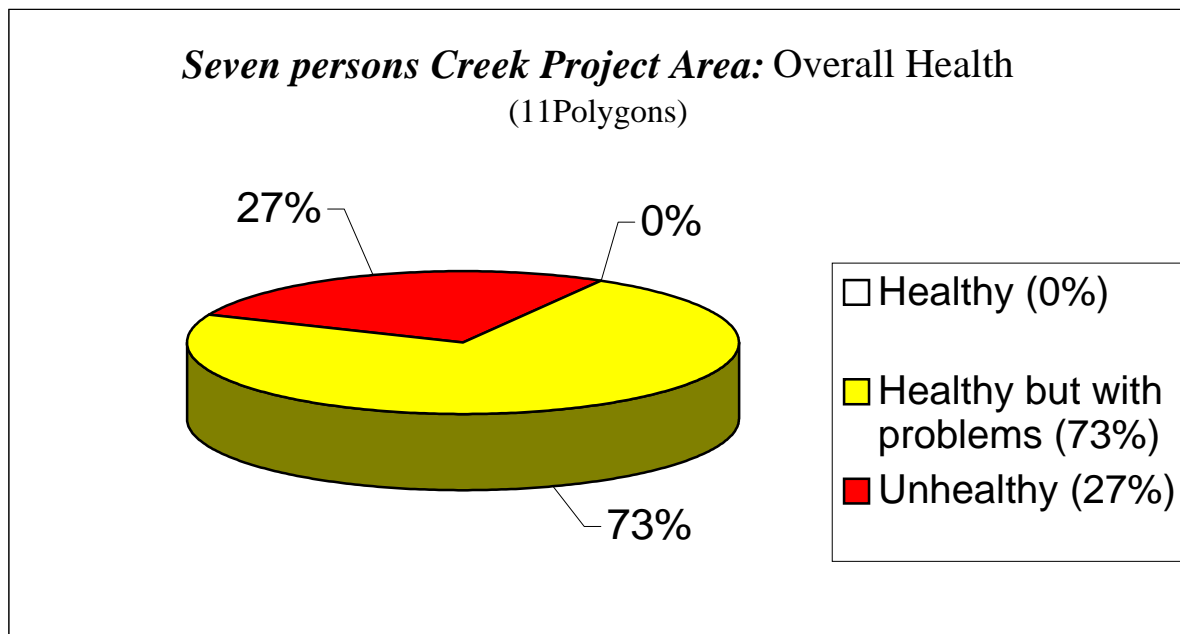
Figure 2. Breakdown of riparian health results for 11 polygons within the Seven Persons Creek project area.

- Of the 11 polygons assessed:
 - 0% (0/11) are *healthy*,
 - 73% (8/11) are *healthy but with problems*,
 - 27% (3/11) are *unhealthy*.
- Please note: due to the small number of polygons assessed these health ratings do not represent the health of the entire Seven Persons Creek watershed.

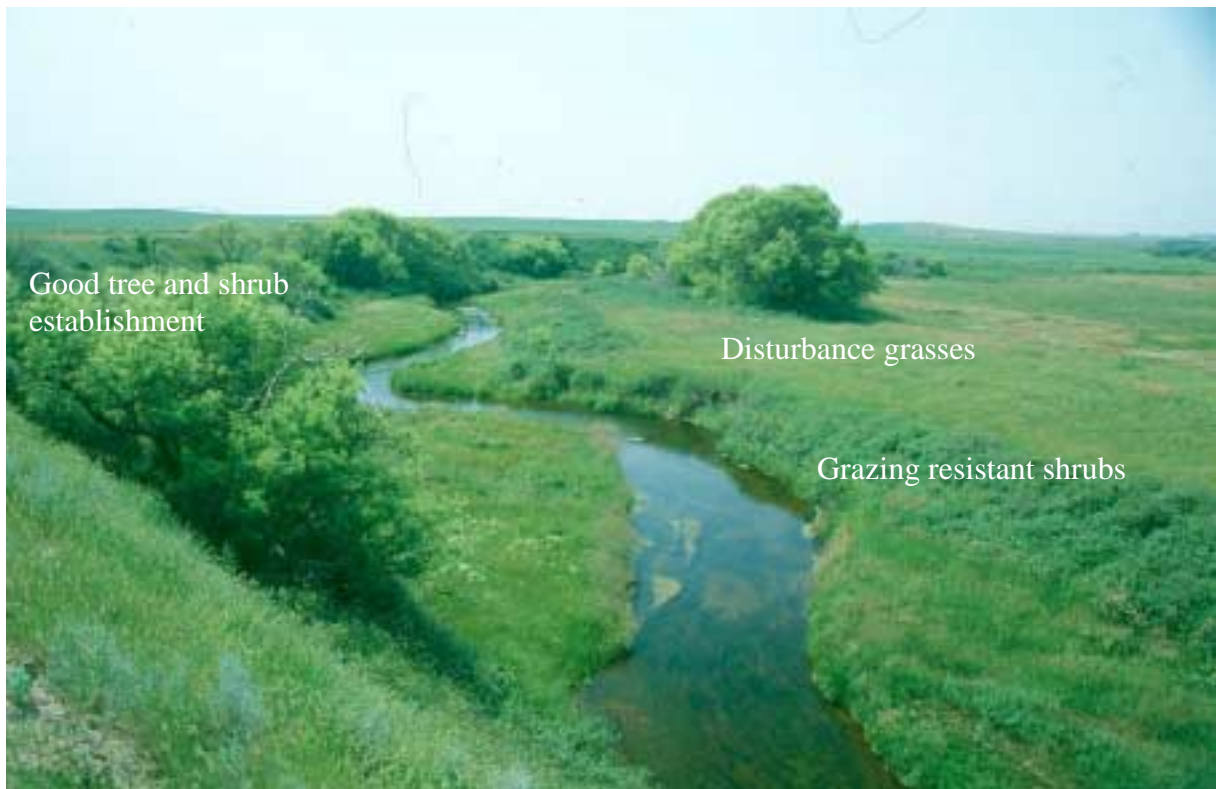
Figure 3. Typical riparian area of Seven Persons Creek.
Photo Credit: Michael Uchikura

Good tree and shrub establishment

Disturbance grasses

Grazing resistant shrubs

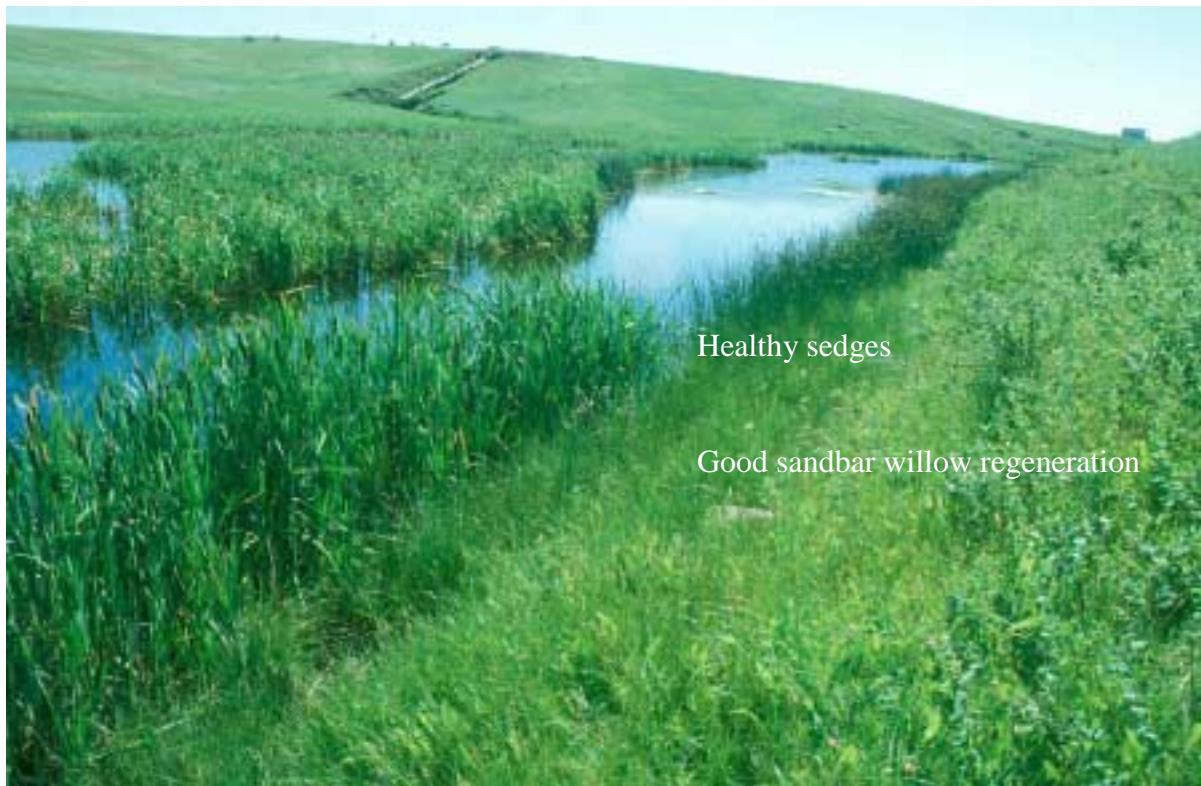
Figure 4.; Typical riparian area of Knodel Reservoir
Photo Credit: Michael Gerrand

Healthy sedges

Good sandbar willow regeneration

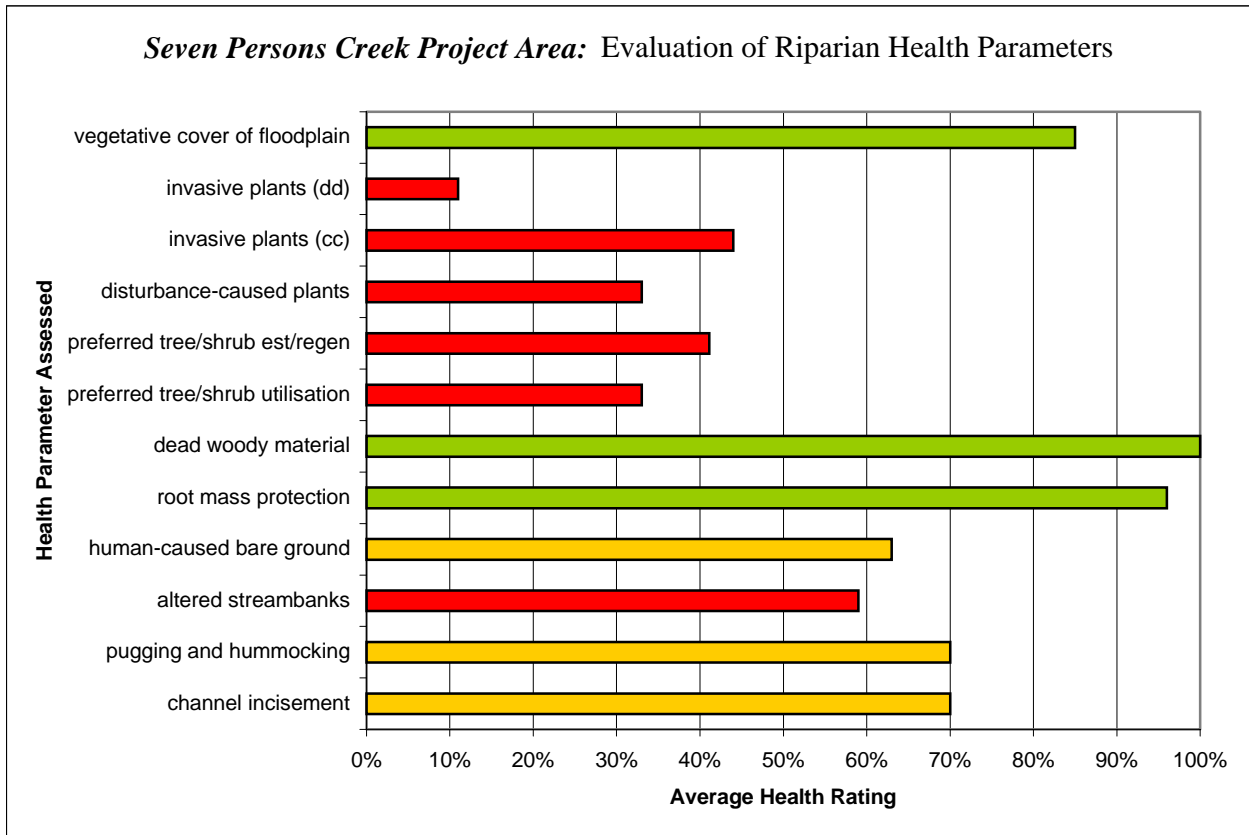
During our assessment of riparian health we looked closely at 11 health parameters and assessed their functioning condition (Figure 6). Six of the parameters relate to vegetation and five relate to soil and hydrology. The score sheet for the Seven Persons Creek project area is in Appendix A. A glossary detailing how each of these parameters is scored is in Appendix B. By objectively examining each of these health parameters we can determine which *pieces* are adequately performing the necessary functions of a healthy riparian area, and which are not. This examination provides us with a better understanding of where to concentrate efforts if improvements in riparian management are required, and what land use practices are currently maintaining riparian health.

Unhealthy (<60%) Impairment to riparian health parameter due to human or natural causes.

Healthy but with problems (60-79%) Some impairment to riparian health parameter due to human or natural causes.

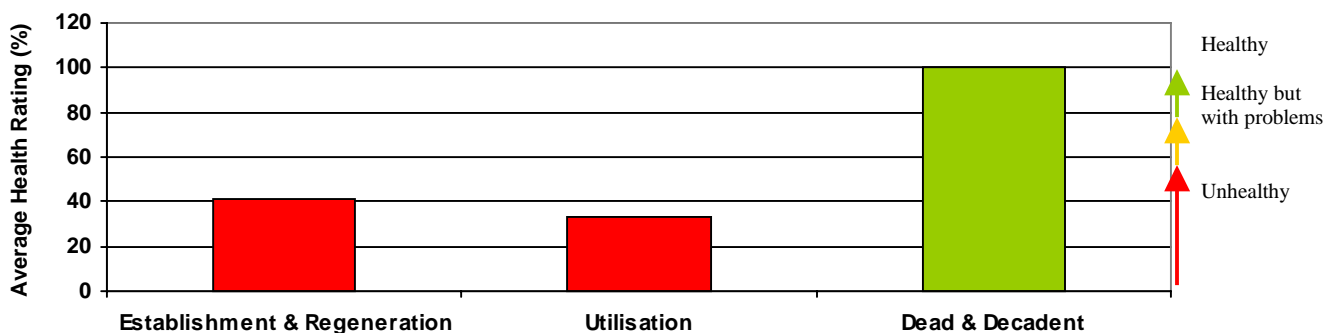
Woody Plants - Trees and Shrubs: Presence, Reproduction and Health

- Three native tree species and 15 native shrub species were recorded within the Seven Persons Creek project area.
- Russian olive (*Elaeagnus angustifolia*) was observed in one polygon.
- Total area covered by all trees and shrubs combined is 24%.
- The presence of trees is negligible and the dominant shrubs are common wild rose, thorny

- Existing tree and shrub communities show normal amounts of dead and decadent branches in the upper canopy. This indicates there is sufficient moisture within the system, and that disease is not a problem in maintaining these communities.
- There are concerns with the overall health of shrubs.
- About half of the shrub canopy cover is comprised of only two grazing-resistant, disturbance-increaser shrubs (snowberry/buckbrush and common wild rose).
- In almost all polygons, preferred trees and shrubs species are receiving moderate to heavy browse pressure from livestock (to a lesser degree wildlife). In many locations this browse pressure is removing new growth and preventing seedlings and saplings from reaching a mature age class.
- The indicators of heavy browse pressure are *umbrella-shaped* mature shrubs and *flat-topped* or *hedged* seedling and saplings.

- **Increase rest period from grazing during the growing season.** Rest from continuous browse pressure is one step towards maintaining regeneration of existing preferred trees and shrub communities and improving future reproduction and establishment. Attention to livestock management options such as distribution, timing, rotation, and stocking rate should enable preferred trees and shrubs to be maintained and increased. By not addressing browse pressure, existing tree and shrub communities could decline and lesser palatable species could increase (e.g. snowberry/buckbrush and rose).

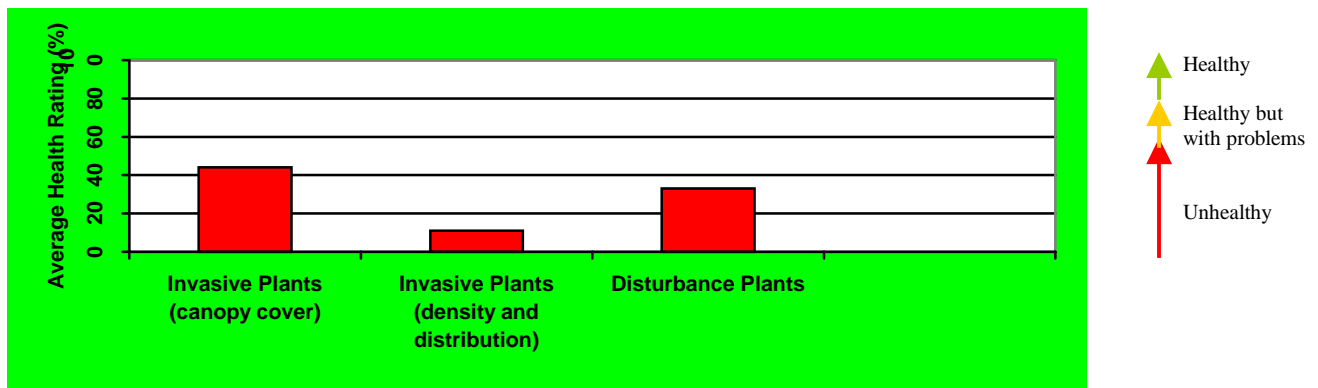
Non-Woody Riparian Plants: Diversity and Health

- 37 species of grasses and grass-like plants (graminoids) and 65 species of broad leafed plants (forbs) were recorded within the Seven Persons Creek project area.
- 66% (67 species) of the non-woody riparian plants recorded are native plants. Native plants provide riparian functions including deep, binding root masses and summer and winter forage production for livestock and wildlife.
- 4 poisonous plant species: showy milkweed (*Asclepias speciosa*), water hemlock (*Cicuta maculata*), common horsetail (*Equisetum arvense*) and Indian hemp (*Apocynum cannabinum*) were recorded within the project area but they were not present in high amounts to cause concern. If poisonous plants were found on any landowner's property, they are identified in the plant list within their individual report.

- Almost all polygons have adequate amounts of plant cover (85-95%).
- About 36% of the project area is occupied by disturbance-caused plants (grasses and forbs). Of the 19 disturbance-caused plants present, the most prevalent are foxtail barley (*Hordeum jubatum*), crested wheatgrass (*Agropyron pectiniforme*), smooth brome and Kentucky bluegrass⁴.

- All polygons except one have greater than 25% of the riparian area covered in disturbance-caused undesirable herbaceous species. Disturbance-caused plants typically do not have a deep, binding root mass and therefore do not provide streambank protection as well as non-disturbance native species.

- Despite the abundance of disturbance-caused plants, native grasses and forbs continue to be maintained within the project area.
- **The prevalence of invasive plants (e.g. noxious weeds) is a concern.** All polygons have sporadically occurring invasive plants from one end of the polygon to the other with large patches in between. Canada thistle (*Cirsium arvense*) and perennial sow thistle (*Sonchus arvense*) are the two most prevalent invasive weeds.

- ***Reduce the presence of disturbance-caused plants.*** Complete elimination of disturbance-caused plants is not realistic, however, with sound grazing strategies the prevalence of disturbance-caused plants could be reduced. From a grazing perspective, disturbance-caused plants do provide some forage for livestock at specific times of the year but require specific management, as they “green up” and mature earlier than most native grasses. Providing maximum rest during the growing season, skim grazing and time-controlled grazing management practices can be applied, to reduce the potential for an increase in these species while maintaining an abundance of native species.

- Achieving the above goals requires ensuring plant communities have enough rest from grazing during the growing season to reduce the amount of bare ground and to allow native plants to out-compete disturbance-caused and invasive plants for nutrients and water. A combination of weed control measures and grazing strategies that consider distribution, timing and stocking rates will be required.

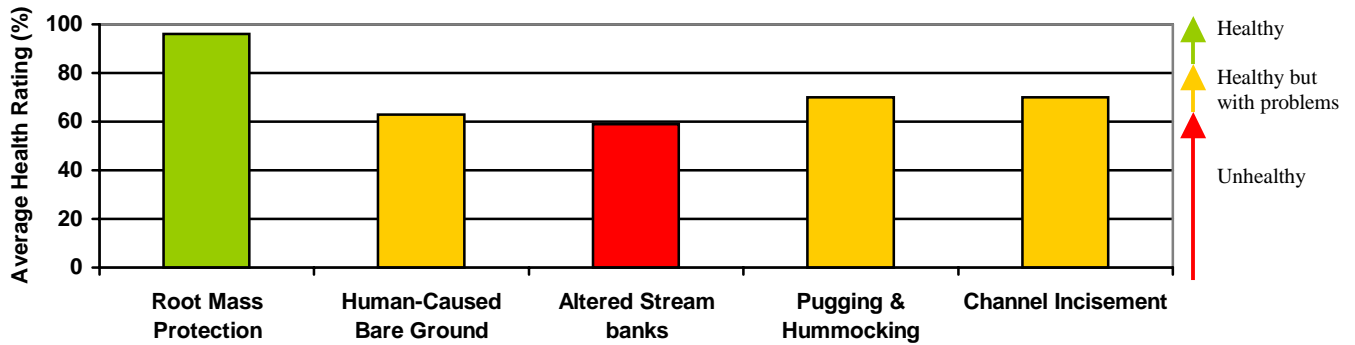
Streambanks and Floodplain: Alterations and Stability

- Overall, the streambanks of Seven Persons Creek project area are in fair condition with 14% of the streambanks within the project area having structural alterations by human activities. There are a few hotspots within Seven Persons Creek project area as four of the nine lotic polygons have greater than 15% of the streambanks structurally altered by human activities.

- The majority of alterations that exist have been caused by livestock activity (hoof shear, trailing). Road construction and stream crossings are contributing to a lesser extent.

- Exposed soil surface or bare ground was not a problem in the majority of polygons. Of the bare ground overall, about one quarter is naturally occurring (depositional material from recent flood events) and three quarters is human-caused. The minimal bare ground that is present is mostly from livestock hoof action. As mentioned above, noxious weeds can quickly become established in areas of bare ground.

- **Reduce livestock access to streambanks and active floodplain** to allow structurally altered and damaged areas time to heal. There is excellent potential for the recovery of the few areas of altered streambanks.

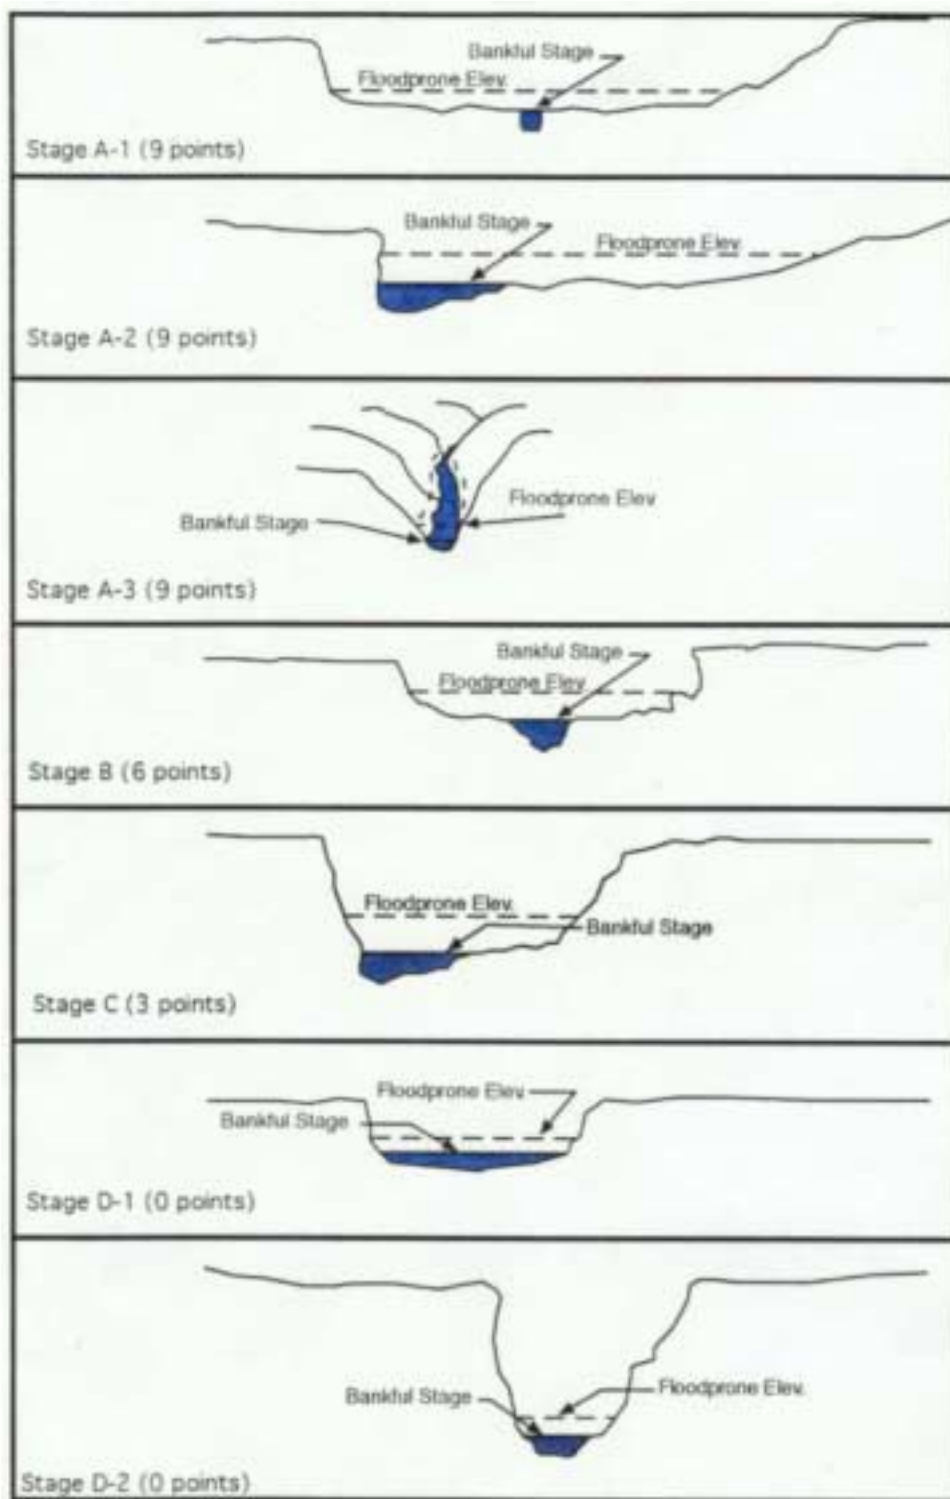
Figure 2. Guides for estimating stage of channel incisement.

9= Channel vertically stable and not incised; 1-2 year high flows access a floodplain appropriate to the stream type. Active downcutting is not evident. Any old incision is characterized by a broad floodplain inside which perennial riparian plant communities are well established. This condition is illustrated in Figure 2 by the following three stages.

Stage A-3. A stable, unincised mountain (Rosgen A-type) or foothill (Rosgen B-type) channel with limited sinuosity and slopes greater than 2%. Although bankfull flow stage is reached every 1-2 years, the adjacent floodplain is often narrower than twice the bankfull channel width. Consequently, overflow conditions are not so obvious as in Stages A-1 and A-2 systems.

6 = Either of two incision phases: (a) an improving phase with a sinuous curve/point bar system (Rosgen C-type) or a narrow, meandering stream (E-type) establishing in an old incision which now represents the new floodplain, although this may be much narrower than it will become; (b) an early degrading phase in which a narrow, meandering meadow stream (E-type) is degrading into a curve/point bar type (C-type) or a wide, shallow channel (Rosgen F-type). In either case, the 1-2 year high flow event can access only a narrow floodplain less than or only slightly wider than twice the bankfull channel width. Perennial riparian vegetation is well established along much of the reach. These conditions are represented in **Stage B** of Figure 2.

Stage D-1. An incised stream with a wide, shallow (F-type) channel. Commonly found in fine substrates (sands, silts, and clays), channel banks are very erodible. Only limited vegetation, primarily pioneer species, is present along the side of the stream.

Stage D-2. A narrow, deep "gully" system (Rosgen G-type) downcut to the point that only extreme floods can overtop the banks. Distinguished from narrow mountain streams (A-type) by the presence of a flat floodplain through which the stream has downcut and by banks consisting of fine materials rather than larger rocks, cobbles, or boulders.
